# **ENVIRONMENTAL TEST REPORT**

MIL-STD-810F

24 March 2009 Test Report No. EC807039 Rev A Date of issue:

Name of Equipment AC-DC MIL Adapter Model No(s) ACMIL2835-ZZZZ

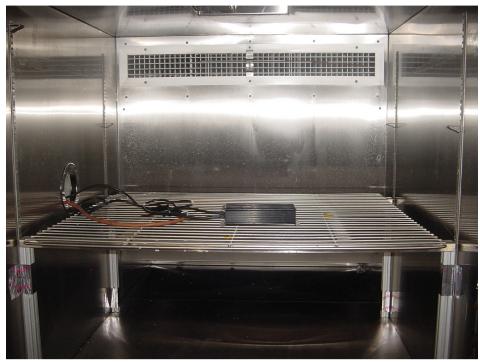
Figure 1: Altitude Test Setup

- The sample was subjected to 15,000 feet at ambient temperature with a transition rate of 7.6m/sec (1496 ft/min).
  - Actual transition rate 5.4m/sec (1071ft/min).
- Altitude to be stabilized at 15,000 feet.
- Pressure to be returned to ambient with a rate of 7.6 m/sec (1496 ft.min)
- Voltage was measured and recorded at load panel pre-test, at 15,000 feet and post test.

The sample functioned at a 15,000 feet. Voltage measured 26.85VDC at pre-test, altitude and post-test conditions. Refer to Appendix A for test photographs and Appendix B for altitude chart.

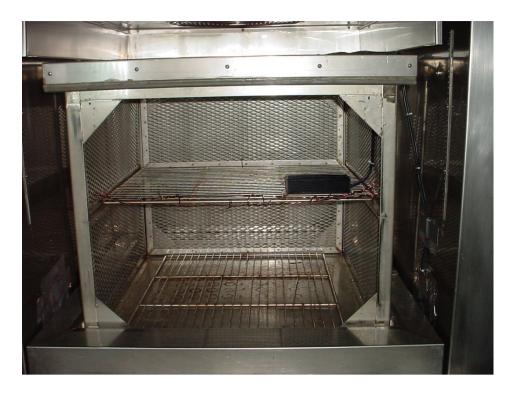
Figure 2: Thermal Shock Test Setup

- The sample was subjected 10 cycles of the following profile:
  - 0.5 hours at 85 ℃
  - o 0.5 hours at -40 ℃
- Voltage was measured and recorded at load panel pre, during and post test.

Voltage measured 26.90VDC pre-test, and 26.85VDC at hot soak, cold soak and post-test conditions. No obvious physical deformation observed upon completion of testing. Refer to Appendix A for test photographs and Appendix B for thermal data charts.

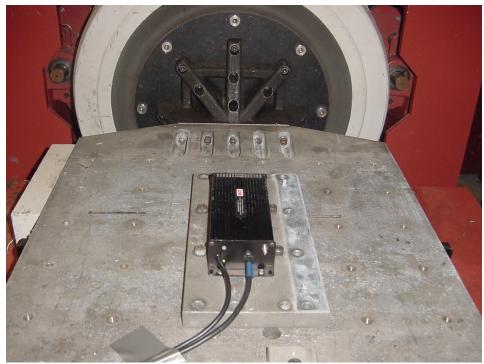
Figure 3: Longitudinal Functional Shock and Vibration Test Setup

- ~ Three shocks in each axis (18 total) both positive and negative
- ~ Terminal Peak (saw tooth)
- ~ 40g's pk, 11 ms
- ~ Operate unit throughout test
- ~ Voltage was measured and recorded prior to and after each axis of testing.

- ~ Random Vibration 200 2000Hz
- ~ The sample was ran 1 hour in each perpendicular axis, operating throughout test.
- ~ Voltage was measured and recorded prior to and after each axis of testing.

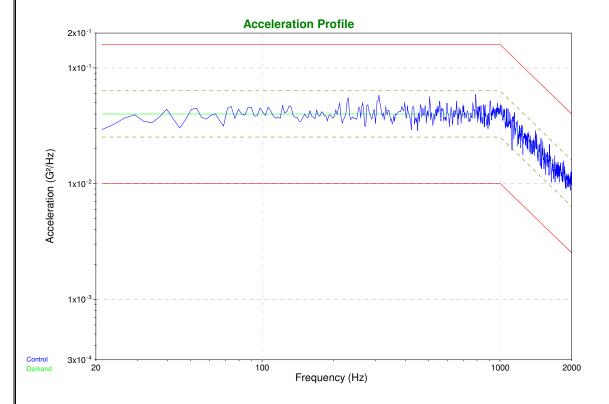
## REPRESENTATIVE VIBRATION PLOT

Frequency	G <sup>2</sup> /Hz	dB/Octave			
20 Hz	0.04	0			
1000 Hz	0.04	-6			
2000 Hz	0.01005

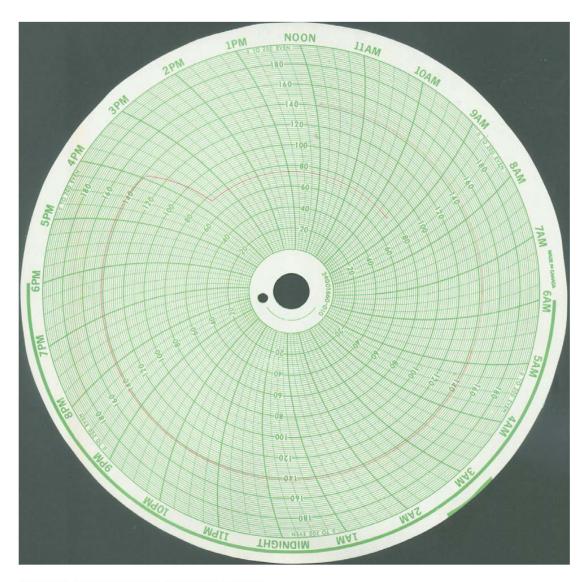
Figure 2: Chamber temperature (°F) chart

A pretest operation test was conducted. The test unit was placed in the dust chamber. The temperature was adjusted to 23°C (73.4°F) with a relative humidity of 21%. The chamber air velocity was increased to 8.9 m/s (1750 ft/min) and the dust feeder was adjusted to provide a dust concentration of 10 g/m³ (0.3 g/ft³). These conditions were maintained for 6 hours.

The dust feeder was turned off and the air velocity was reduced to 2 m/s. The chamber temperature was increased to 60°C (140°F) with a relative humidity of 10%. These conditions were held overnight to allow the test unit to stabilize.

The chamber air velocity was increased to 8.9 m/s (1750 ft/min) and the dust feeder was adjusted to provide a dust concentration of 10 g/m³ (0.3 g/ft³). These conditions were maintained for 6 hours.
